Surface Finish Treatise in Relation to Cylinder Liners

by Eric Willis

GKN Sheepbridge Stokes Limited

June 1984

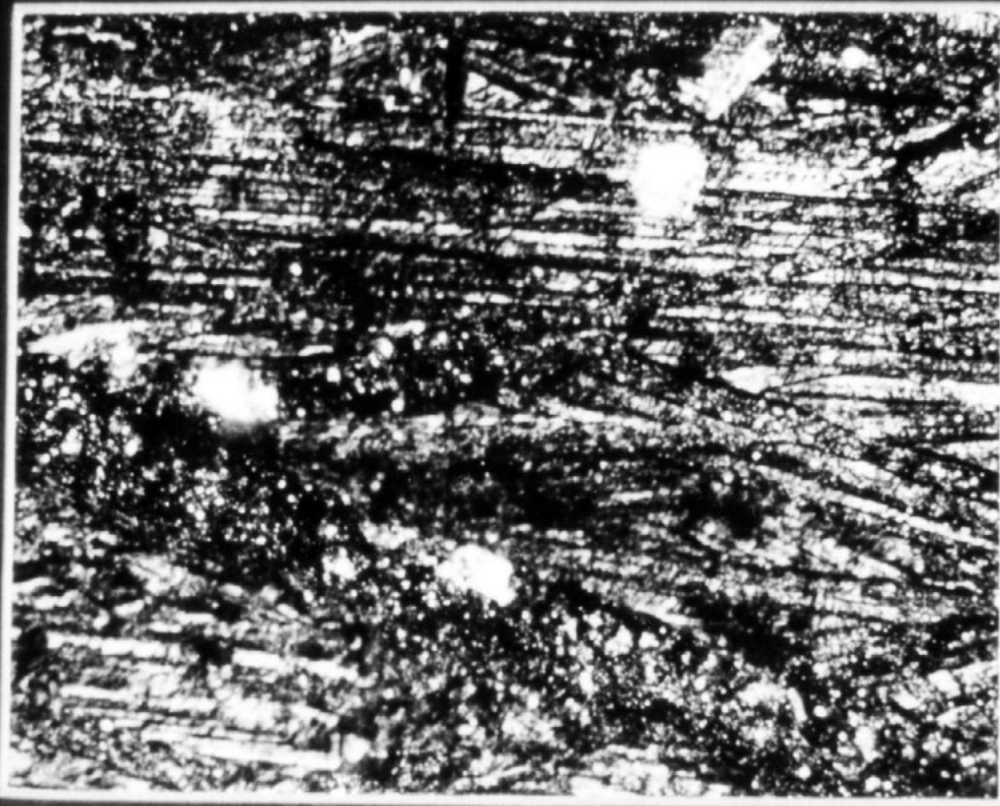
Finish Honed Bore

Viewed under polarised light

x 400

Showing heavy distribution of Non Metallic inclusions
impregnated into the bore surface by the use of
Diamond Honing Stones.

My real investigations in the surface finish of cylinder liner bores came about when studying engines with scuffed cylinder bores. Surfaces from these cylinders were examined using a polarized light source and found to contain non-metallic inclusions (FIGS 3 & 4). To further investigate these non-metallic inclusions, samples were viewed by an Electron Scanner Microscope which, in turn, revealed differing sources which could be attributed to scuffing.

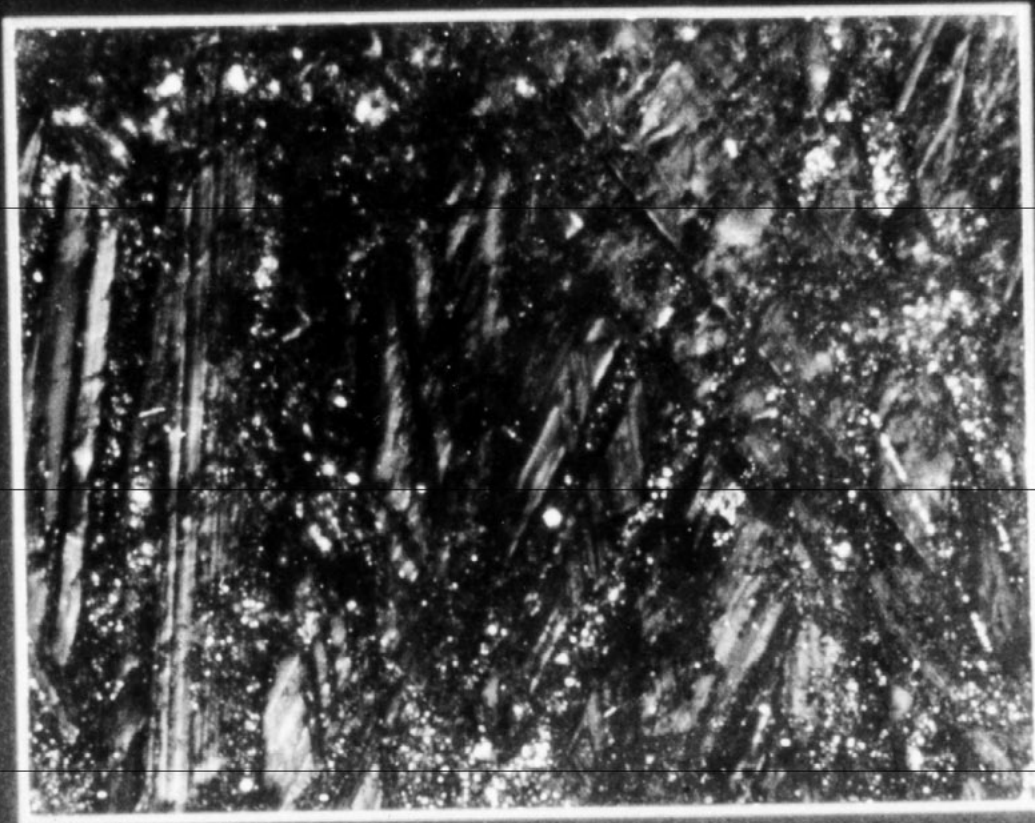
Finish Honed Bore

Viewed under polarised light x 800

Showing very light distribution of Non Metallic inclusions impregnated into the bore surface by the use of Silicon-Carbide Honing Stones.

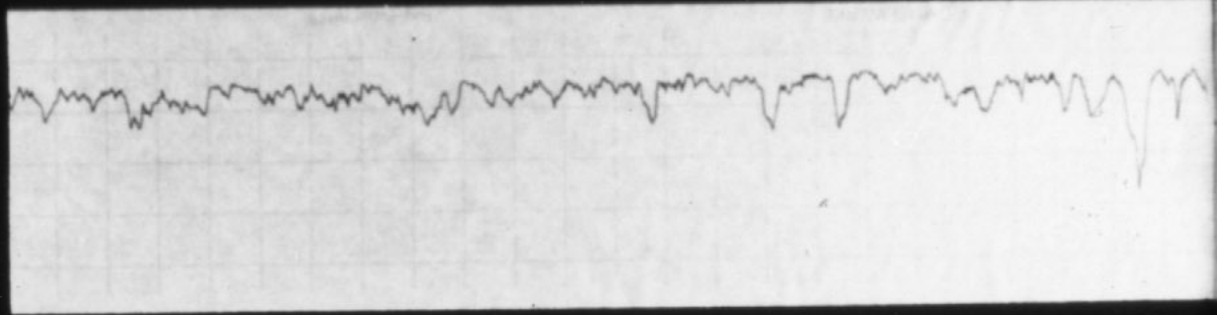
Plateau Surface

RT = 12.2000V/H
 RH = 12.2000V/H
 RZ-1 = 9.2500V/H
 RZ = 8.7500V/H
 RP = 3.2750V/H
 RPH = 2.7500V/H
 RQ = 1.4000V/H
 RZ2 = 4.4500V/H
 RZ2H = 5.3500V/H
 RI = 12.9200V/H
 RJ = 2.7500V/H
 RK = 90
 CL = 0.0000V/H
 TPI = 2.0000V/H 12%
 TPA = 2.0000V/H 42%
 L = 4.5000V/H
 LU = 2000 ft 5000 ft
 LH = 100 ft 10000 ft
 LC = 0.0-100

The topography using this method gave a cutting effect finish to the plateau and minimised folding over (FIGS 9 & 10), this being distinct from a smooth plateau by using Rubber or Cork tools. This finer cutting action on the plateau surface enabled rings to bed with the cylinder walls in the running-in period, instead of promoting a glazing effect which is apparent from the very smooth plateau produced by Rubber or Cork tools. Engine performance with liners produced in this manner has so far proved exceptionally successful, for running in and oil consumption.

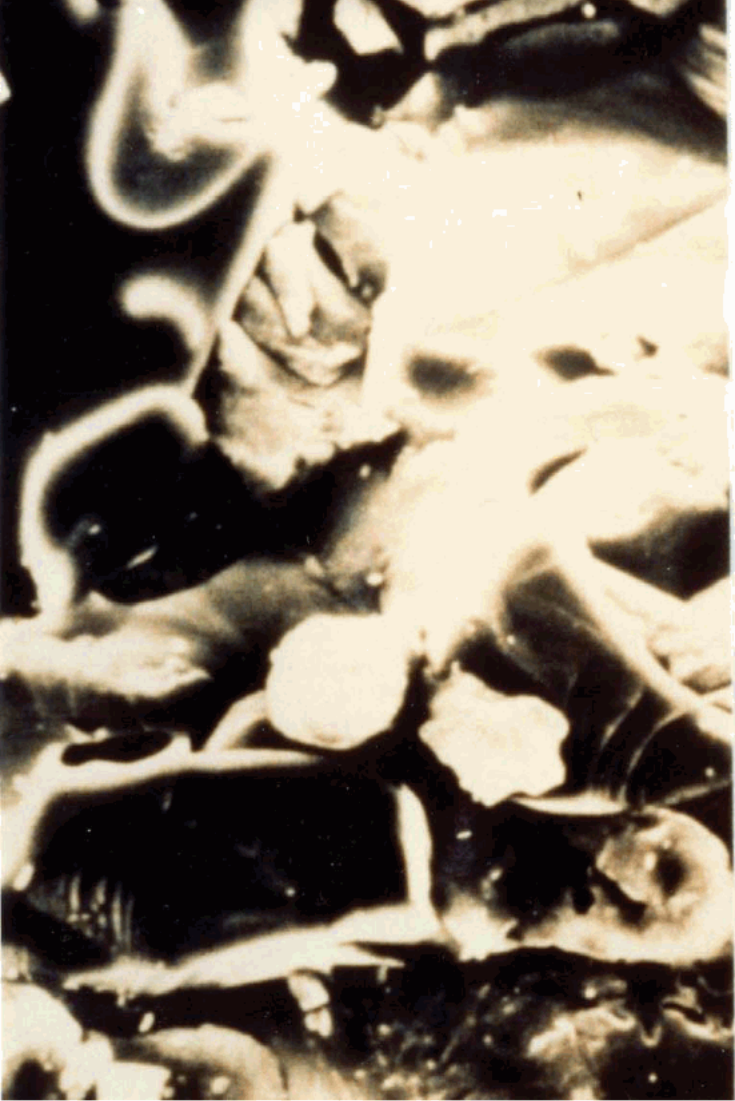
During the course of this study it had been observed that the talysurf trace showed evidence of a spurious valley not evident to the naked eye (FIG 13). This valley or scratch mark, having no pattern,

Even if you moved the piece very slightly the stylus would find it difficult to locate the scratch again. However, curious with the findings we searched deeper, increased the magnification on the Electron Scanner Microscope to 3,000 times and was amazed with what it revealed, crushed and crazed material (FIG 16), frightening to a degree, but realised this must have been happening throughout the years in the manufacture of cast iron cylinder liners. Believing it was the honing tools that was creating this crushed material condition, we made numerous changes with pressure, coolants, feeds and speeds, but to no avail. On each occasion when viewing on the Electron Scanner Microscope at 3,000 times magnification the same results appeared, crushed metal. The fine boring operation gave the same effect and in the first cutting operation which is applied to a casting this crushed metal is initiated (FIG 17), machining further material of approximately 0.25 mm by fine boring and subsequent honing crushed metal is still apparent. May be it is something we cannot remove, and is of no detrimental consequence to an engine.

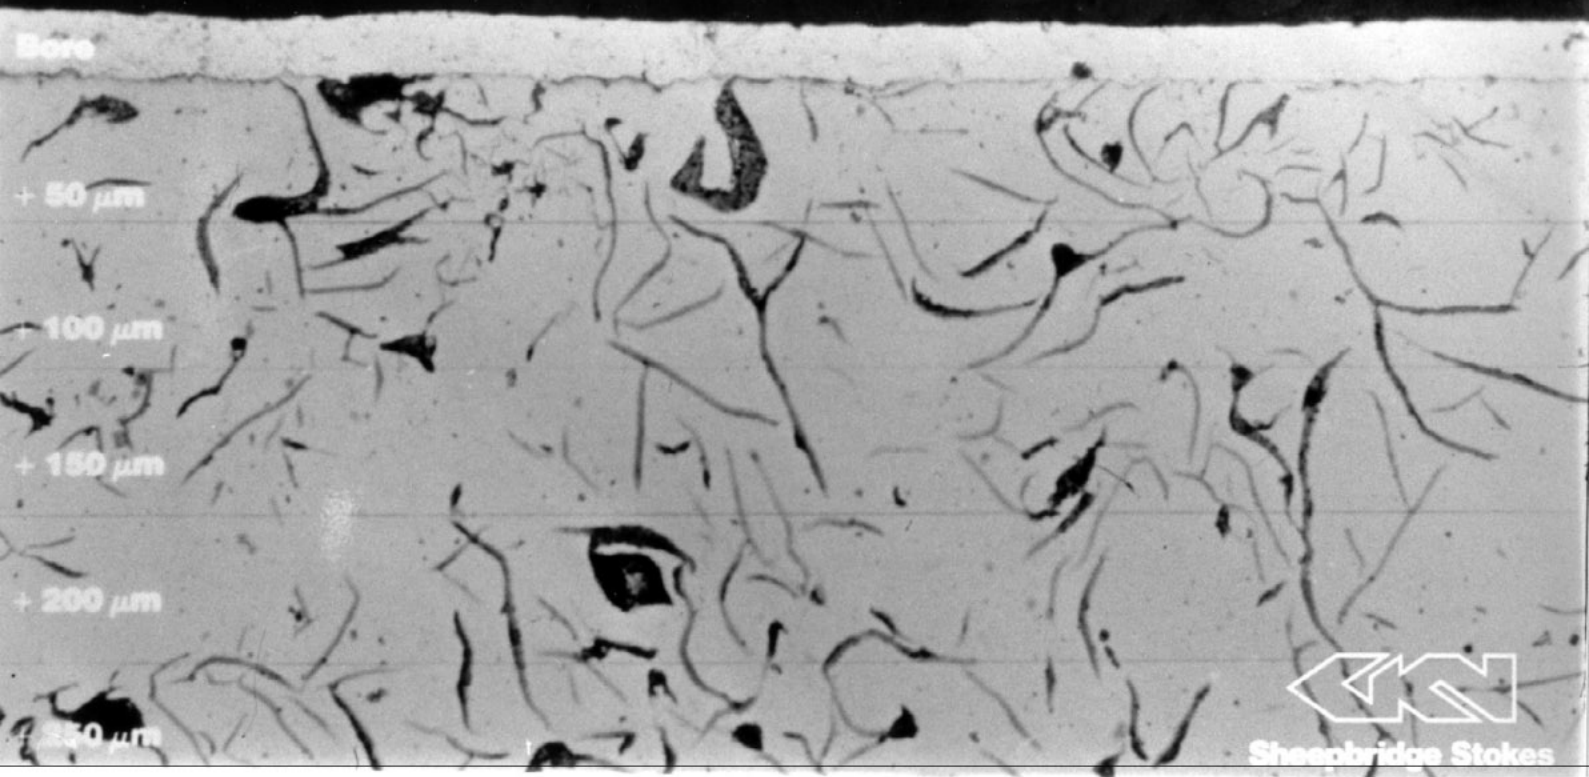
Graphite Flakes

Left

Right

Upright

"Pinched"

and rolled flakes are visible, therefore, it must be discounted that the machining process is the prime factor in creating this condition (FIG 18).

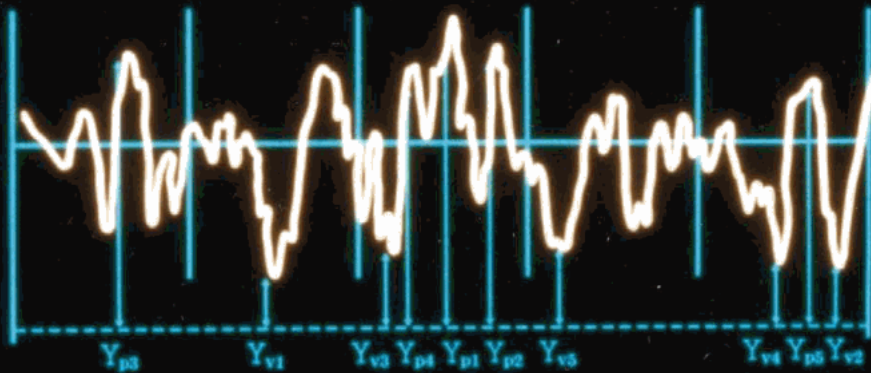
R_z (ISO)

R_z Also known as the ISO 10 point height parameter, is measured on the unfiltered profile only and is numerically the average height difference between the five highest peaks and the five lowest valleys within the traverse length.

$$R_z \text{ (ISO)} = \frac{(Y_{p1} + Y_{p2} + Y_{p3} + Y_{p4} + Y_{p5}) - (Y_{v1} + Y_{v2} + Y_{v3} + Y_{v4} + Y_{v5})}{5}$$

$$= \frac{1}{5} \left(\sum_{i=1}^{i=5} Y_{pi} - \sum_{i=1}^{i=5} Y_{vi} \right)$$

- a) The Rz I.S.O which is a ten point height parameter (FIG 21), it is measured over a single sampling length and an average of several peak values. Numerically, it is the average height difference between the five highest peaks and the five lowest valleys within the sampling lengths. It is not the measurement that we recommend to be used, again variations can take place which can be rather misleading.
- b) The Rz D.I.N. method is an average roughness depth (FIG 22) in five sequential measuring lengths, we consider this the best average method of measuring a surface finish. The Rz D.I.N. factor is good, better in our view than Rz I.S.O and gives excellent guidance should you require control throughout the works on instant readout instruments, when the production methods have been evaluated.

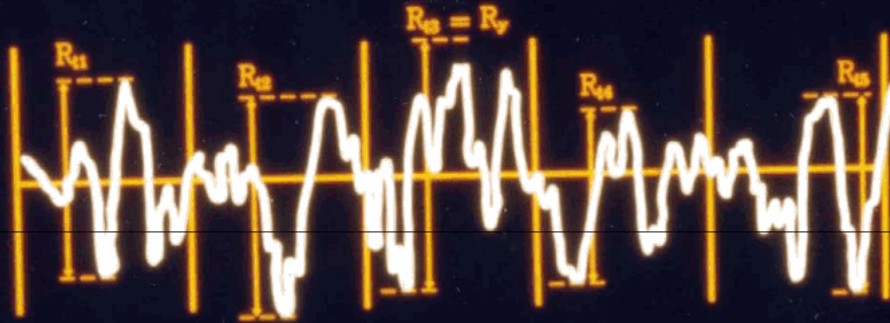
R_{q1} , R_y , R_{tm} (R_z DIN)

R_{q1} R_{q1} is the maximum peak-to-valley height of the profile in one sampling length.

R_y R_y is the largest R_{q1} value within the assessment length.

R_{tm} R_{tm} is the mean of all the R_{q1} values obtained within the assessment length. It is the equivalent of R_z DIN.

Where n = number of cut-offs, then

$$R_z(\text{DIN}) = R_{tm} = \frac{R_{q1} + R_{q2} + R_{q3} + R_{q4} + R_{q5}}{5} = \frac{1}{n} \sum_{i=1}^{i=n} R_{qi}$$

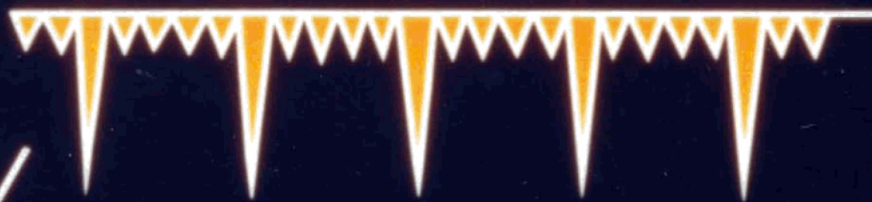
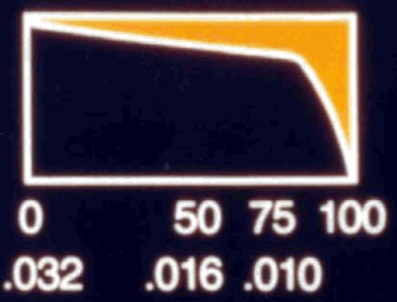
SAMPLING LENGTH L

OIL RESERVE mm³/cm²

RZ

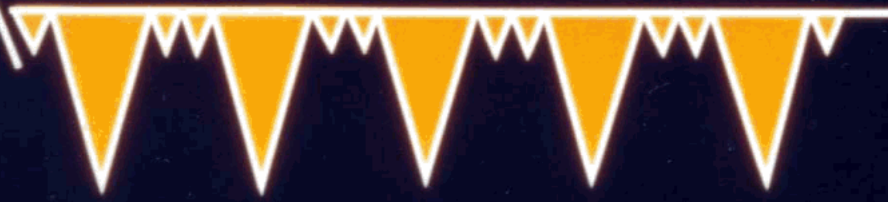
OIL RESERVE mm³/cm²

The one parameter remaining after all the others have been changed due to running in and wear is the oil reservoir, which in my opinion is the most important.

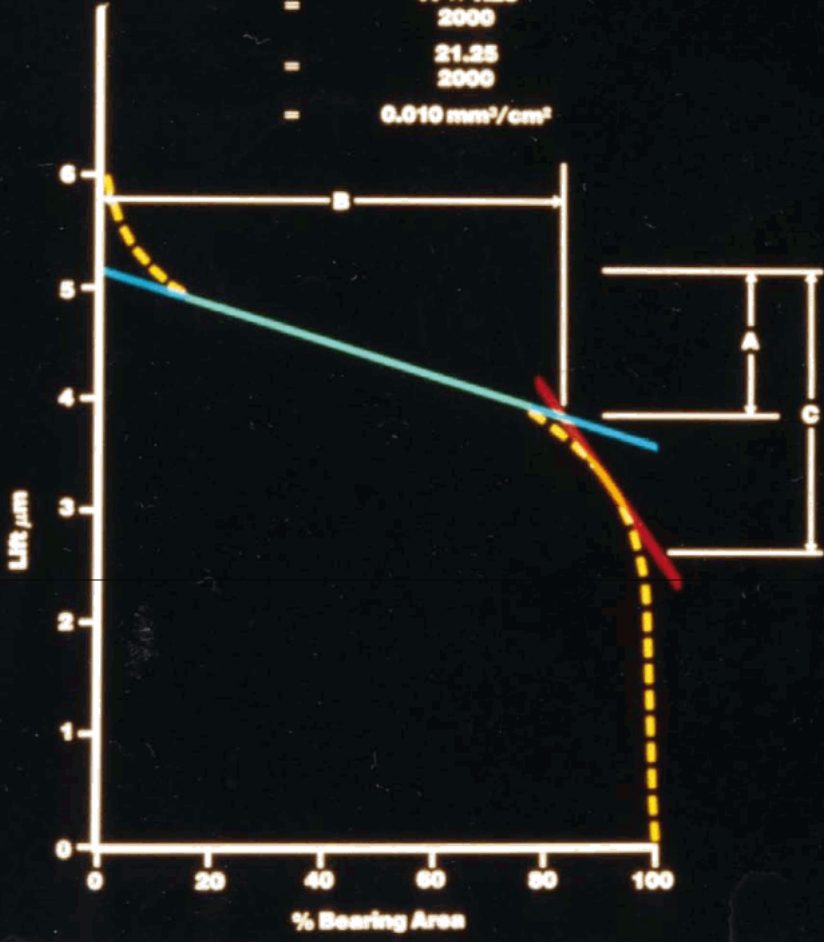
Volume
 Oil Reserve - $(100 - B) (C - A) \text{ mm}^2/\text{cm}^2$
 - $\frac{2000}{2000}$
 - $(100 - 83) (2.55 - 1.3)$
 - $\frac{2000}{2000}$
 - 17×1.25
 - $\frac{2000}{2000}$
 - 21.25
 - $\frac{2000}{2000}$
 - $0.010 \text{ mm}^2/\text{cm}^2$

The initial development stages of determining the oil reservoir was rather laborious, all the slice levels were plotted, a triangle evaluated to roughly calculate the oil reservoir. It was not a complete volume, some of the oil reservoir was missing from each side of the triangle (FIG 24). Having taken a new measuring instrument, the Hommel T20, Hommelwerke were asked if they could manufacture a micro-chip to fit in this instrument to enable the oil reservoir to be calculated at any % bearing area we wish to call, (FIG 25) After many calculations and discussions with Hommel, the chip materialised, was tested and correctly evaluates

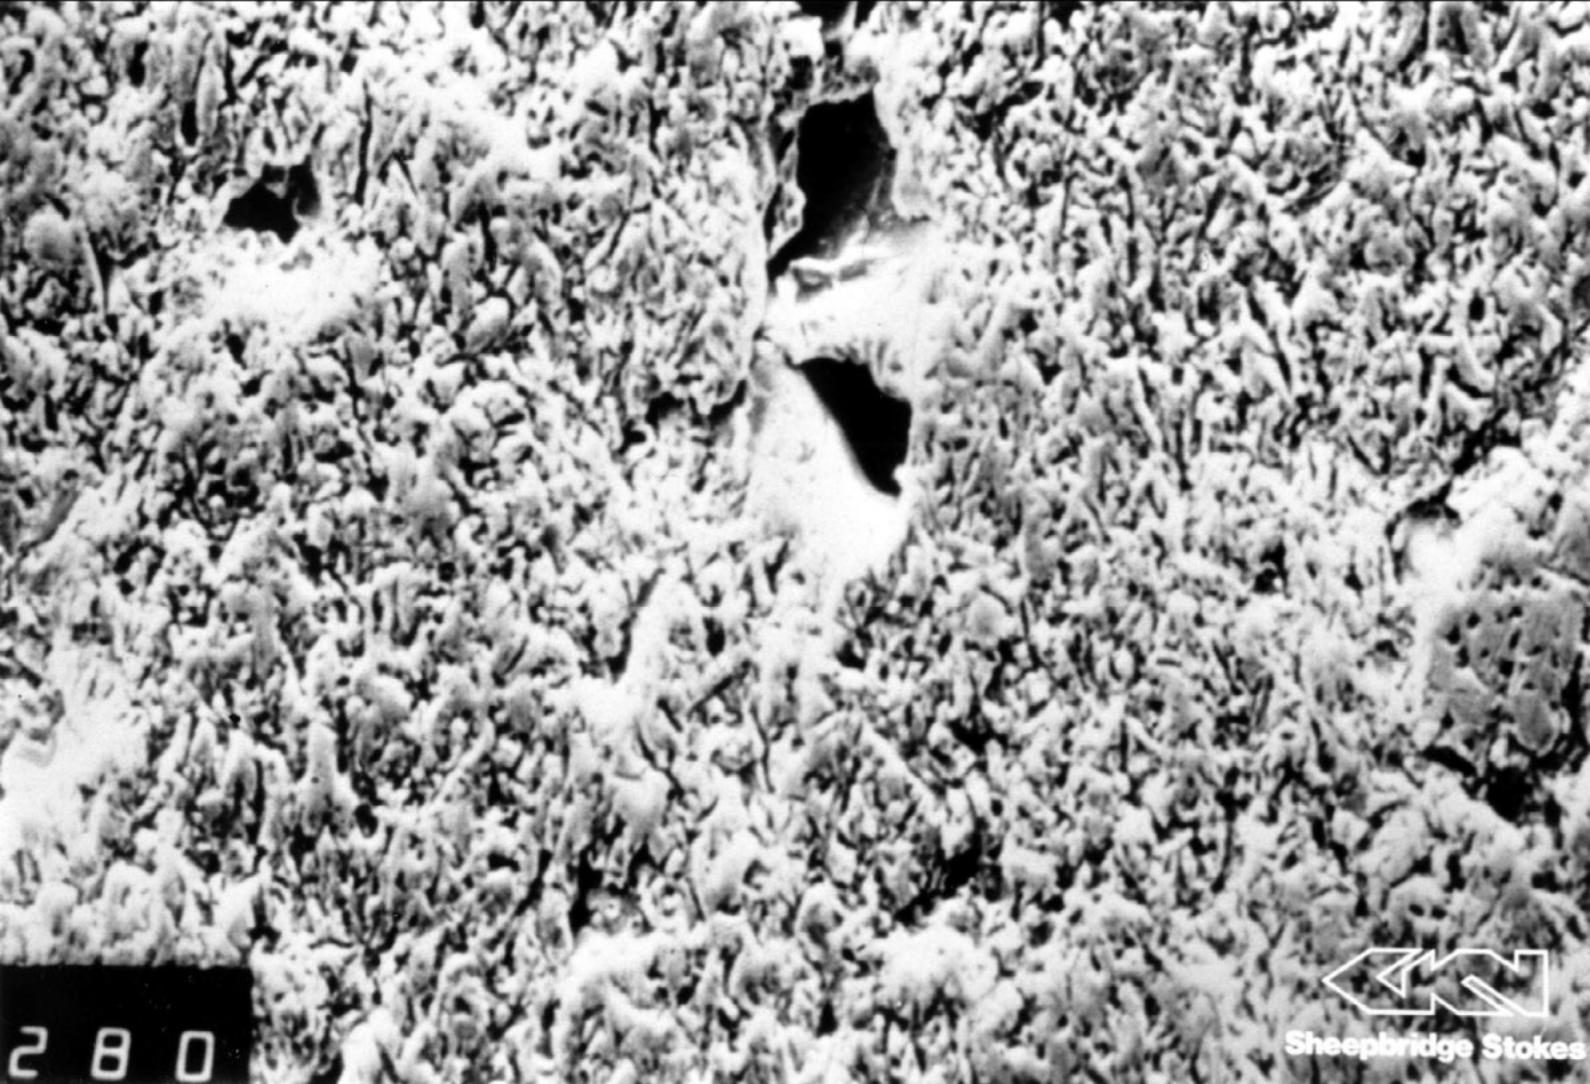
Having the advantage of this broad spectrum, we can, by careful location marking, follow the wear behaviour throughout the cylinder bore life, giving further knowledge to the Engine Designer in his quest for better performance (FIG 31).
